Schneider AG

DUAL GmbH

### Service - Info

Unit type : Chassis DTV 101

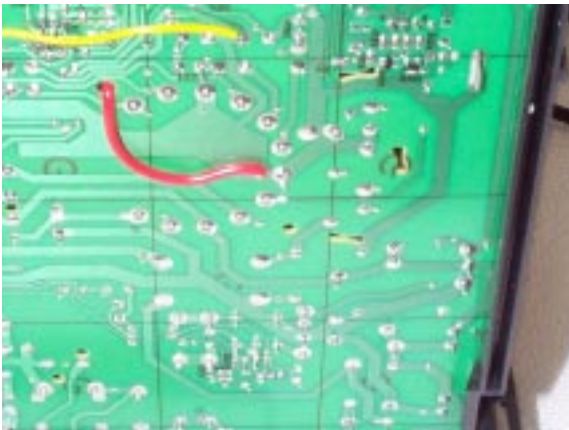
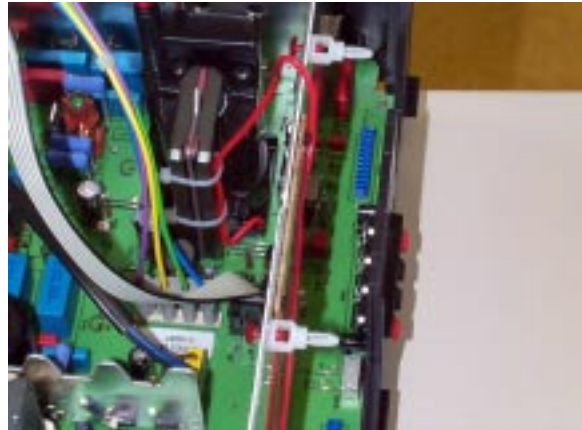
Reducing of vertical shadows by dark video informations.

- ① Change the frame clamp at the right side of the screening from the signal P.C. board through a fixed short ground connector. Solder in a second fixed short ground connector from the left side of the signal P.C. board screening to the frame of tuner.
- ② Control the compensation cable and fix it like the illustration:

The compensation cable, which is soldered in at pin 7 of the diode split transformer, has to be passed through the hole at pin 1 to the ferrit tube. The compensation cable has to be fixed with two cable ties in the middle of the ferrit tube, runned between the cooling shield and the screening of the signal P.C. board and soldered in at the frame of tuner.

**Attention:** To reduce the vertical shadows, the compensation cable has to be layed correctly.

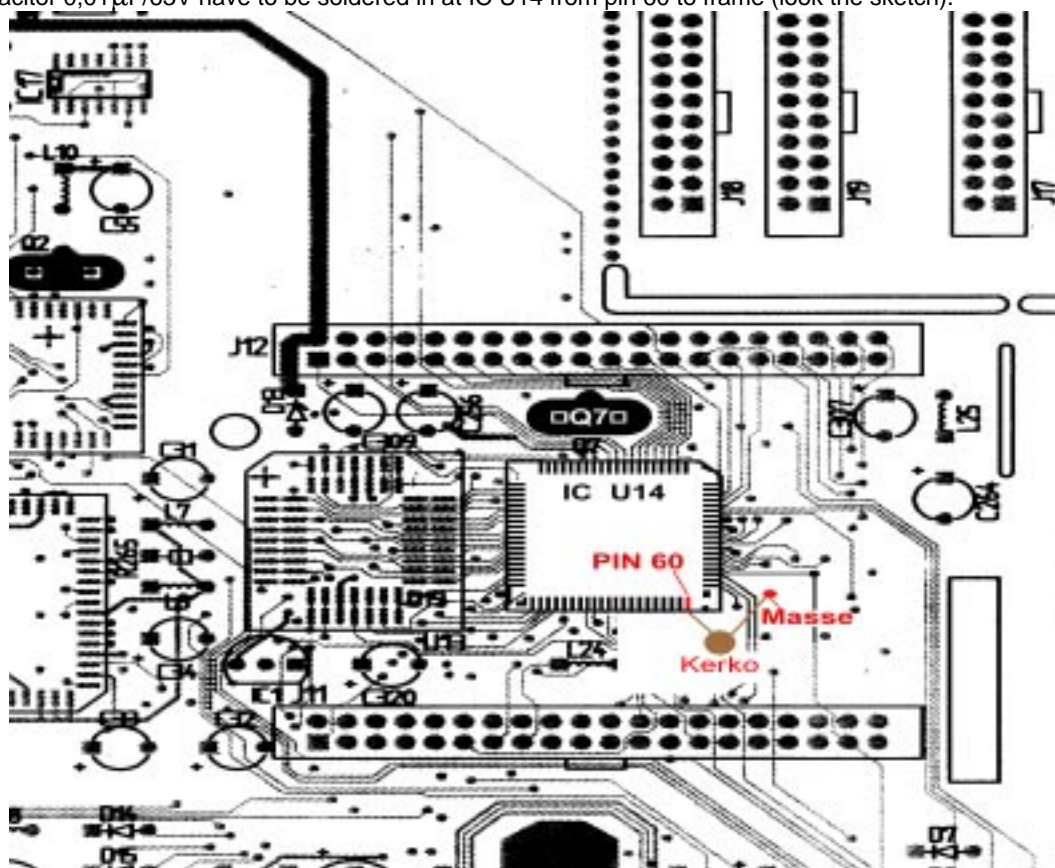
Disturbance at channel 4

- A capacitor 0,01 $\mu$ F/63V have to be soldered in at IC U14 from pin 60 to frame (look the sketch).

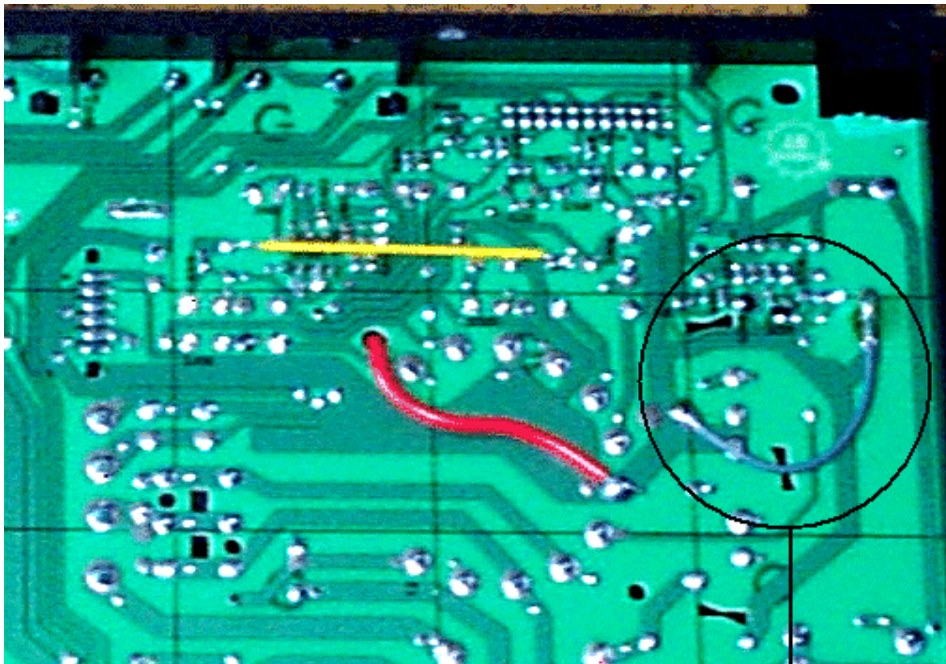
Frame connection

Vertical interference pattern

Extra frame connection cooling plate deflection (see illustration)

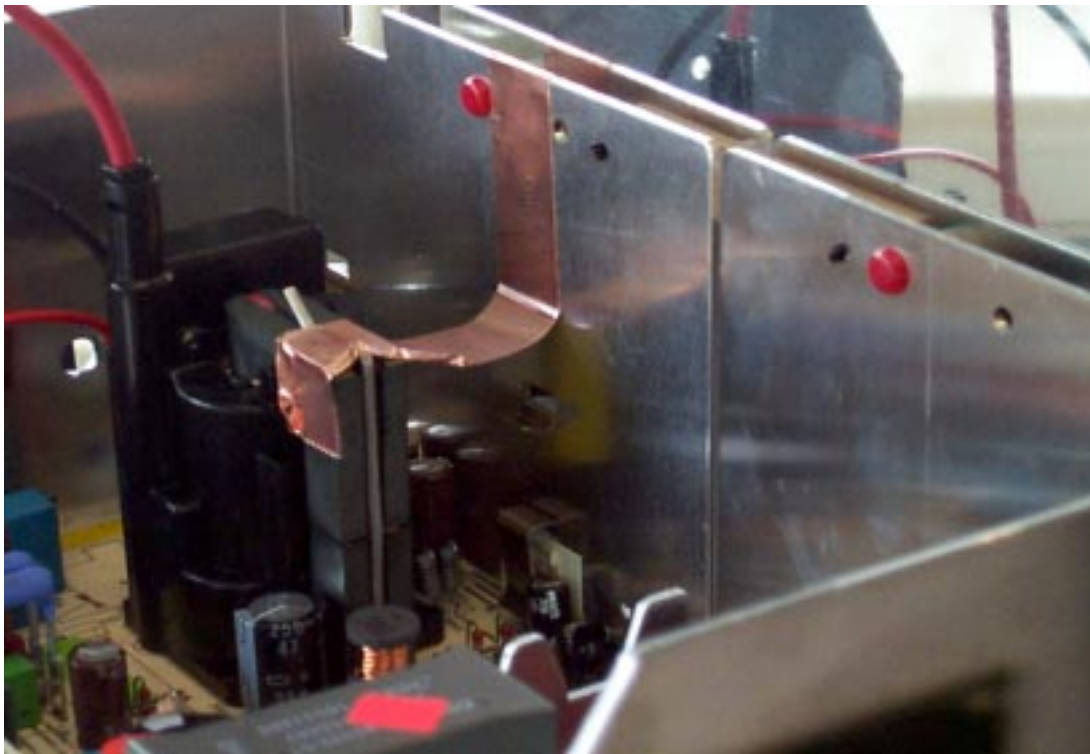
Static discharge of diode split transformer - ferrit tube.

A short ground connector between the diode split transformer - ferrit tube and the colling shield trough a copper conductor (like illustration).

Part number copper conductor: 0104749

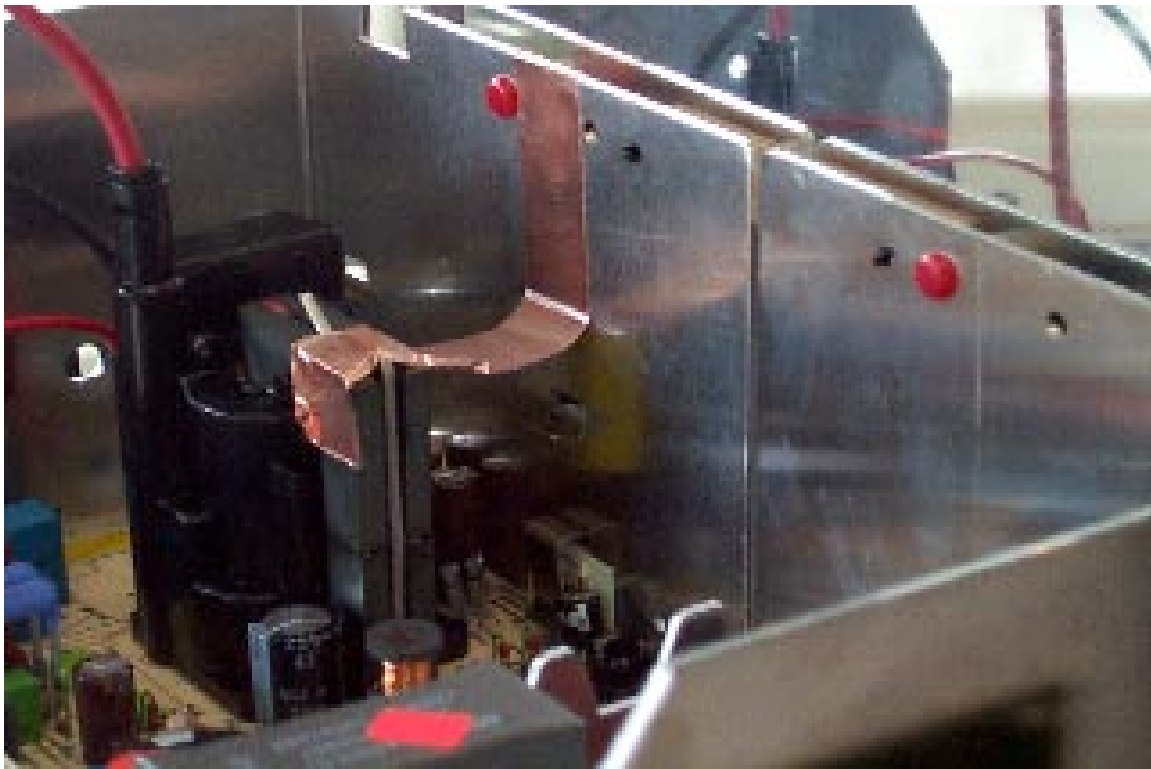
Breakdown of the vertical output amplifier (IC 401 / TDA 8177 F)

- After the breakdown of the vertical output amplifier ( IC 401 / TDA 8177 F ) the soldering connections in the area around the vertical amplifier and the east/west correction have to be observed or soldered again respectively.
- The capacitor 2,2 nF / 100V (part no.: 0061416) has to be componented additional between pin 3 of IC 401 and ground.
- The copper conductor between the diode split transformer - ferrit tube and the cooling shield has to be componented a like the following illustration.

Part number copper conductor: 0104749
