Project Yaigol

Part 2. The PLL (continued)

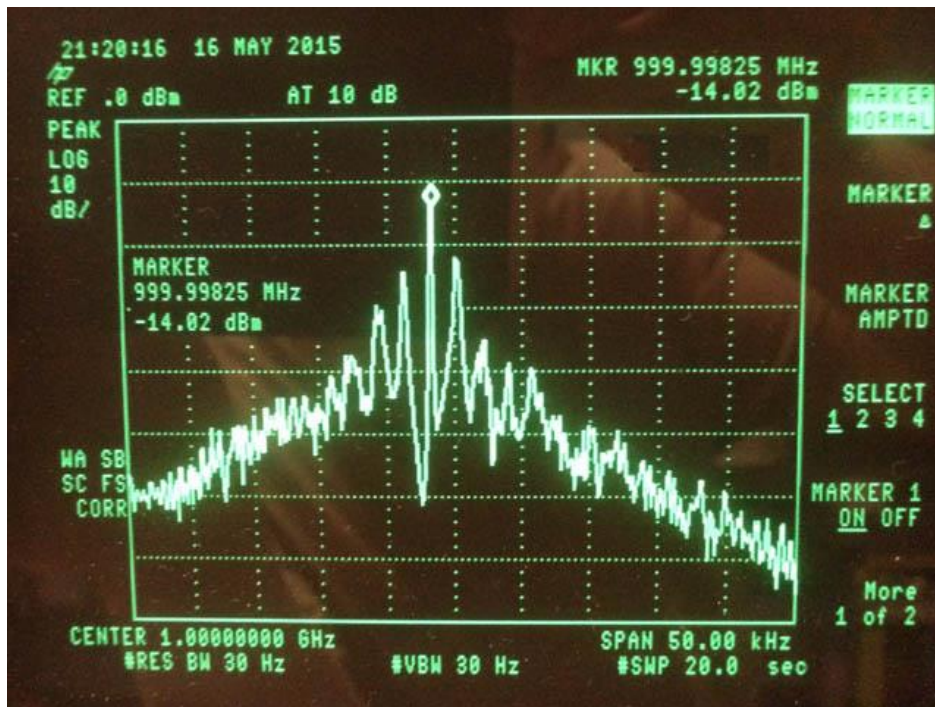
I went ahead and replaced the loop filter on the PCB. This improved the situation but was not what I expected. The PLL was still wobbling with modulation around the carrier and within the loop filter bandwidth. Modulation was suppressed out of band but the noise level was high.

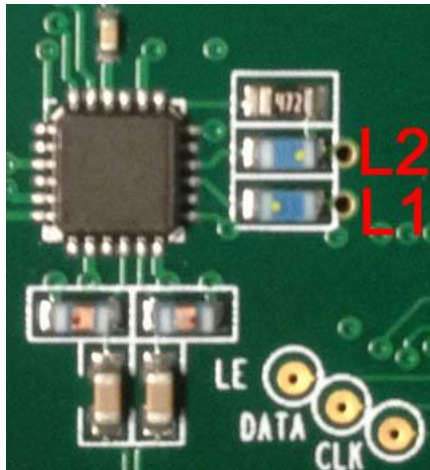
I scratched my head for a while thinking what else may be wrong. I trusted the ADI simulator, I used it many times and it always came up with working circuits. There was not much else to try. I have checked and eliminated the reference oscillator before. I replaced the loop filter. What else left were the output inductors and the VCO inductors. I did not consider the output inductors would give trouble. So, hmmm..., let's take a look at the VCO inductors, here they are again, to the right of the PLL chip:

What can be possibly wrong with them? Well, an RF person would tell right away that they should have been positioned at right angle to reduce coupling. Same says the PLL Datasheet: ...“To reduce mutual coupling, the inductors should be placed at right angles to one another.” I always place any adjacent inductors at right angle. Any RF designer would. Not Yaigol Yingineers. All they needed to do is to read the Datasheet. They did not. Neither they had a clue about the basics of RF design.

Anyway, before trying to unsolder and reposition the inductors I went with trying to determine their value. It was a bit difficult as the part number and manufacturer was unknown, so I tried to search for 0603 inductors dot marking and a few sources pointed out the Yellow dot could be a mark for 2.2nH inductor. The PLL Datasheet page 22 has a formula for calculating the inductor values, which for 1GHz frequency produced 3.18nH, almost 1nH more. The ADI simulator produced a value of 3.15nH. On the PCB the inductors ground ends connect to the ground with two vias, that could add some inductance but I did not know how much. I decided to unsolder and reposition the inductors at right angle.

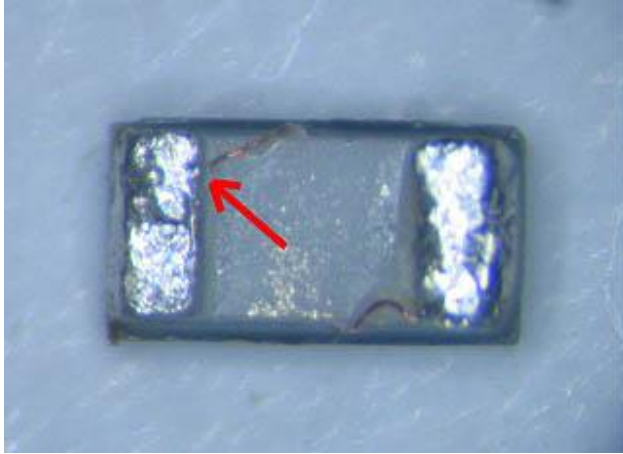
I went ahead with unsoldering L1 and added a tiny bit of a wire to one of the pads in order to be able to position L1 at right angle to L2. However the PLL stopped working and no output was observed at all. I measured L1 continuity and there was no continuity, so I thought perhaps I damaged the inductor. I unsoldered it and threw it under the microscope. What I found was a cheap ass wire wound inductor with the wire ends soldered to the terminals and not cold welded, as a reputable manufacturer would do. I also saw one wire end disconnected from its terminal. Apparently when I unsoldered the inductor the first time, I disturbed the winding and the inductor went open circuit because nothing held the winding ends in place, just a blob of solder. What a piece of shit. I tried connecting the loose wire back to its terminal but could not. I then unsoldered L2 and threw them both out to garbage. Here is a picture of the Yaigol shitty inductor on the left with the arrow pointing to the broken end, and a on the right is a picture of a good quality inductor – note the ends are cold welded, so they do not detach from the terminals during solder/desolder.

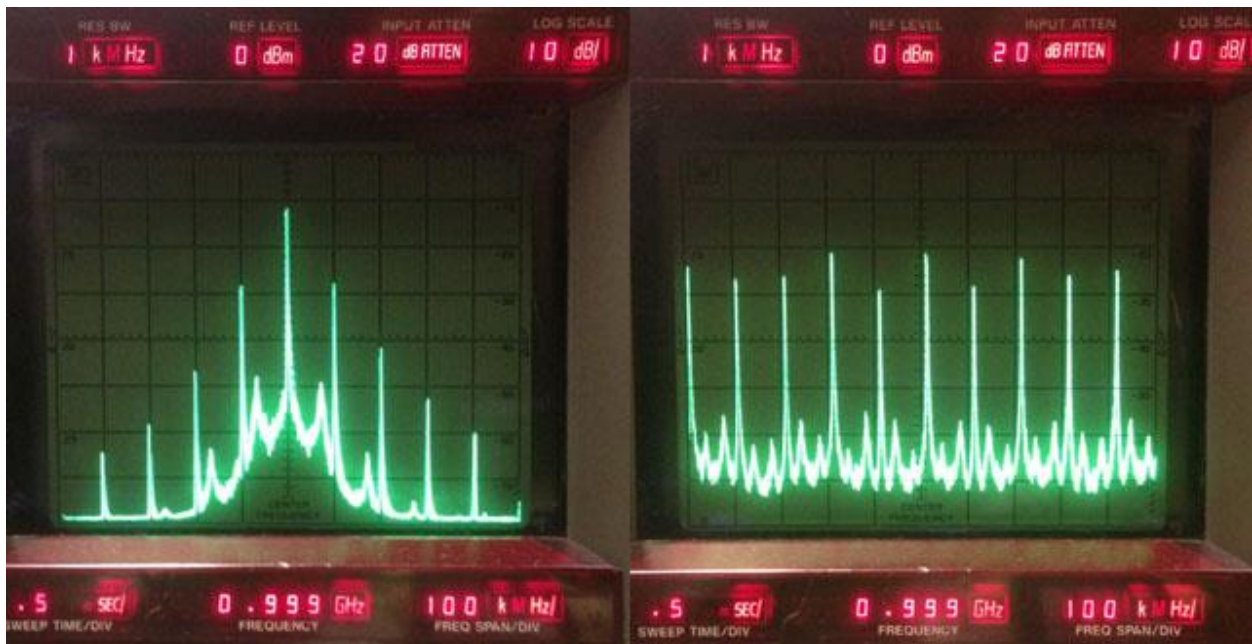
I did not bother trying to resolder them at right angle because the PLL Datasheet and ADI simulator were saying you need 3.1...3.2nH. I went ahead and tried a 2.7nH in parallel and at right angle. Here is the result. The left picture is the inductors are in parallel. The right picture is the inductors at right angle.

So orientation of the inductors did matter. I figured out from the slope of the VCO control voltage that the VCO was running lower in frequency with the inductors soldered in parallel orientation. Therefore the overall inductance was higher than with inductors at right angle. On the other hand, the left picture with the parallel inductors looked better, and since it was with a higher inductance then perhaps I needed to try even larger inductance. I did not have a 3nH inductors so I tried 3.3nH:

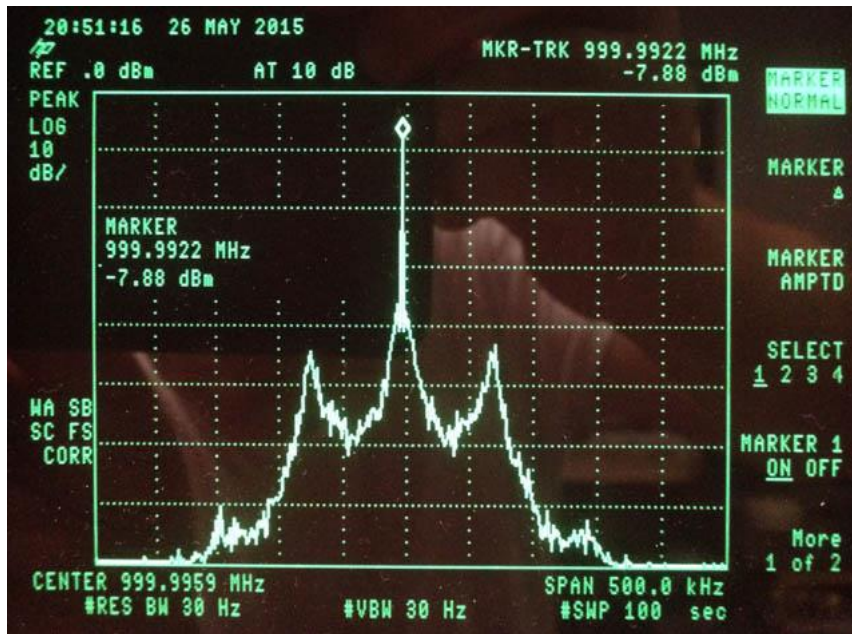
OK baby that drives us closer to home. But ... why do those bat wings look familiar... where did I see them? Hmm... More on this later. For now, I still wanted to try 3.0nH which was in between of 2.7 and 3.3 that I have tried. I searched Digikey for wirewound inductors and found a 3nH 0805 inductor which I not exactly liked because it had black resin coating. I anyways bought a pair but when I tried them the PLL was kind of back to where it originally was, even worse. I unsoldered one inductor and carefully measured with my HP 8753C network analyzer. Sure enough, it was 3nH at low frequencies but its inductance dropped drastically at 1GHz to 2nH. I did not bother taking a PLL screenshot with them.

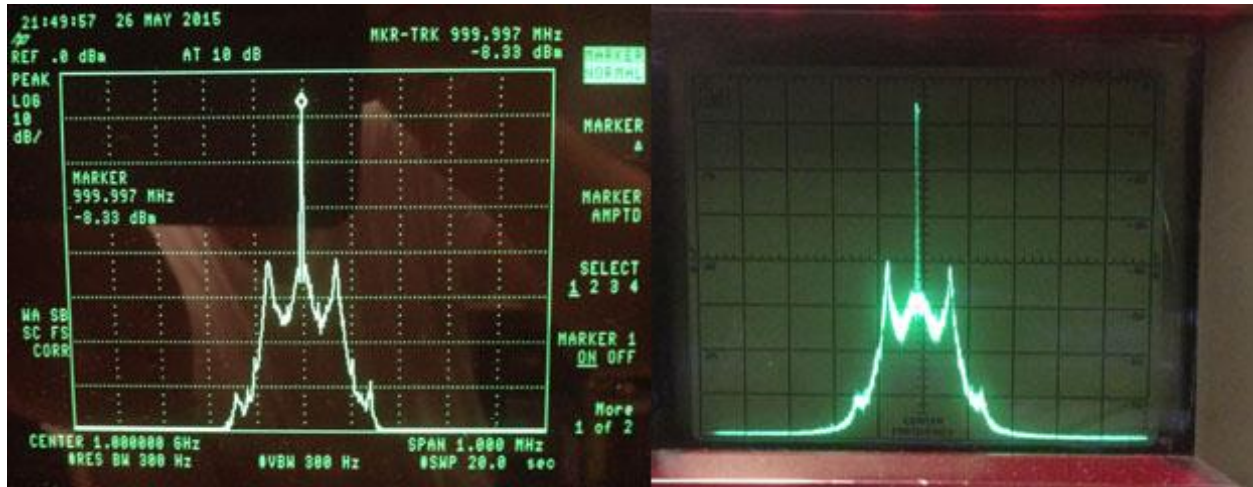
The following are screenshots of the PLL output with my home made inductors of about 3nH taken with two different HP spectrum analyzers. Looks about 60dBc/Hz in-band noise if to recalculate to 1Hz bandwidth:

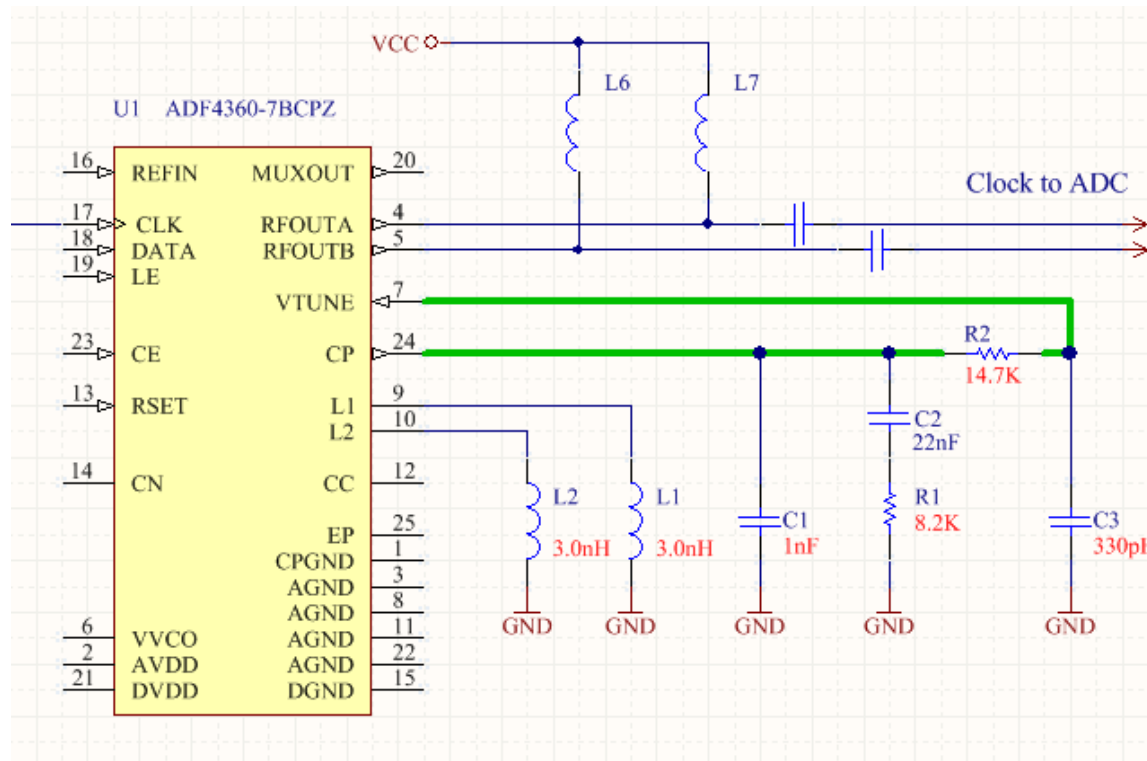
DS2000 oscilloscope PLL is disfunctional on factory oscilloscopes. The two main reasons identified are:

- Incorrect selection of the PLL loop filter component values for the given PFD frequency
- Incorrect selection of the PLL VCO inductor values

- Replace the PLL loop filter components with the values shown in the below schematic
- Replace the two PLL VCO inductors blue-ish color inductors with two 3.0nH inductors. You can either buy or make them from 7mm length of #30 wire as I described above. If you buy them, you must go with wire wound inductors (0603 or 0805) with air core or ceramic core. Do not buy inductors with ferrite or phenolic core. Do not buy multilayer inductors, inductors with resin coating or thin film inductors– they all may change inductance at high frequencies.
