Project Yaigol

Part 4. Other Power Supplies

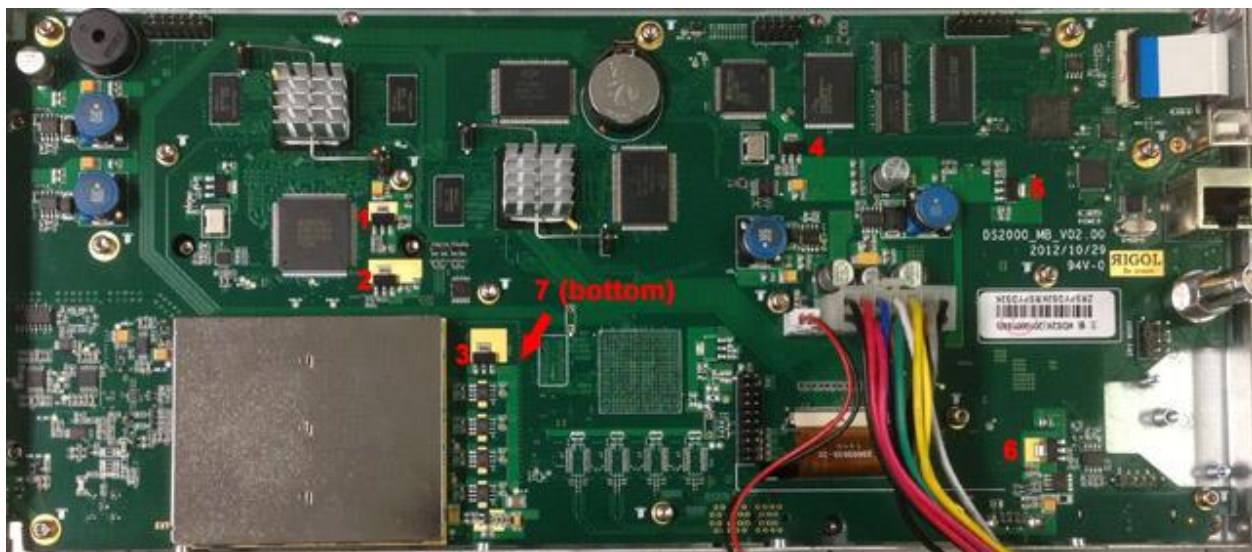
I still had the front panel attached so I could only have access to the PCB top side. The board has seven of 1117 LDO regulators marked in **Red** in this landscape photo. Six regulators on top and one (#7) on the PCB bottom:

- **All 1117 LDO regulators in DS2072A were oscillating.**

1. +2V ADC Digital
2. +2V ADC Analog
3. +3.3V Trigger stage
4. +1.5V
5. +1.4V
6. +5V
7. +5V Input Attenuator control (located on PCB bottom side)

I also replaced the output capacitors on the regulators #4 to #6. I will not bother you with screenshots, they all show oscillation before getting fixed. Just locate them using the landscape board photo and replace the ceramics soldered to the LDO's metal tab. Observe polarity on the replacement capacitors.

- Replace the LDO output ceramic capacitor with a tantalum 10uF 10V...16V capacitor (observe the tantalum capacitor polarity). Use the landscape board photo at the beginning of this section to locate LDO regulators #1 to #6 on the PCB top and #7 on PCB bottom.

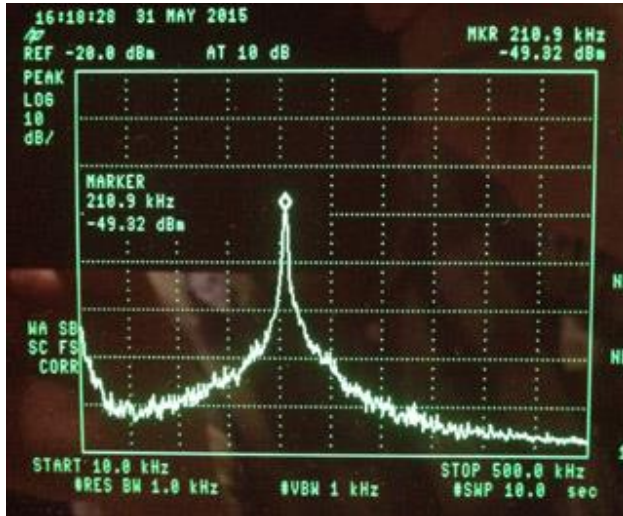
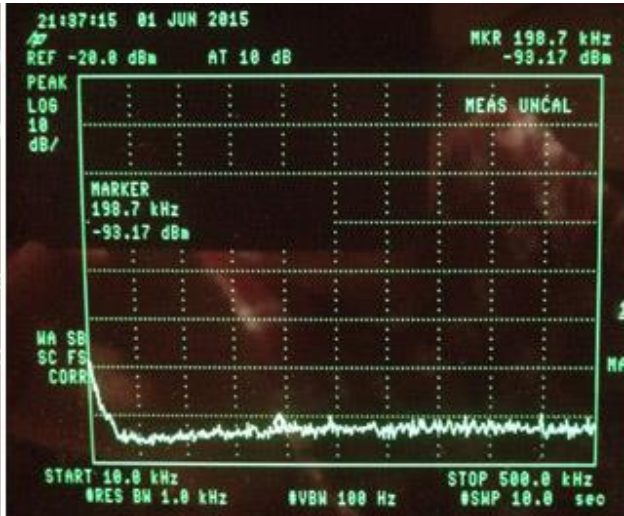
LDO #1 Before

I started from #1 and #2 which are the ADC DVDD and AVDD +2V regulators. I checked the output rails with the spectrum analyzer, sure enough they were bad bad bad. I went ahead and replaced the output ceramic caps. Here is the screenshots for #1 and #2 before and after the fix:

Mind you those are the ADC power regulators. Do I need to repeat? The ADC power regulators. The screenshots on the left are what you have in your Yaigol now. The pictures on the right is what you will have after you do the fix. You gain a 40dB improvement in ADC supply noise.

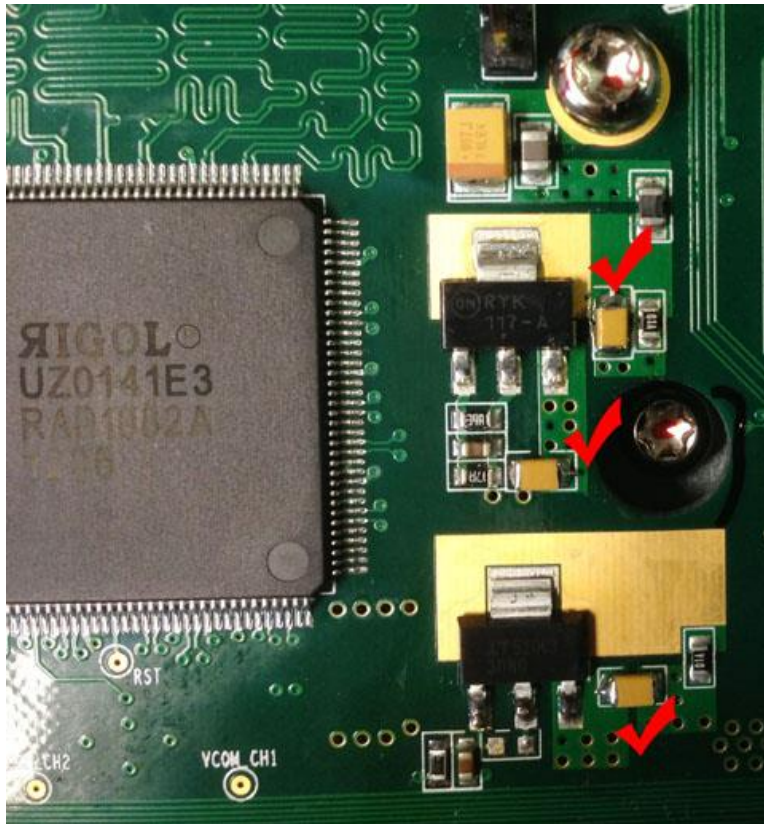
For your reference here is a photo of LDOs #1 and #2 with the output capacitors replaced with tantalum caps:

It seems I also replaced the input capacitor on LDO #1 for some reason, perhaps I saw it improved noise at the LDO input. I also replaced the LDO #2 (ADC Analog VDD) with a low noise LT 3080 adjustable regulator. You do not have to do this. I just attempted to minimize ADC supply noise as much as possible. LT1038 requires only one set resistor, so I removed one of the divider resistors and replaced the other with a new value calculated using the formula in the [datasheet](#).

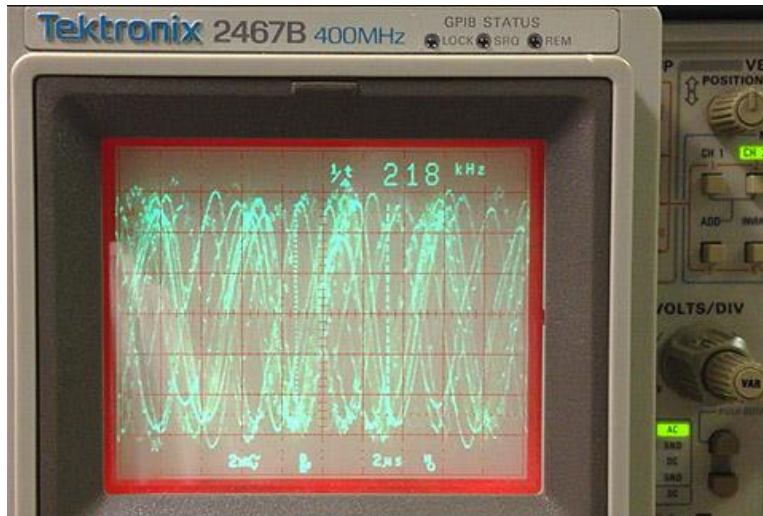
If you look again at the landscape photo of the annotated board, there are 5 more voltage regulators under the LDO #3, four in SOIC-8 and one in small SOT23 package. Those are the input stage power regulators. They are low ESR tolerant parts and did not oscillate but they shared the input +6.3V rail with the LDO #3, and that 6.3V rail was horribly oscillating at about 220kHz and some of it passed right through the input stage regulators and into the scope analog front-end. In fact it was the worst oscillation out of all I have seen so far in this crappy scope. Here is a screenshot of the 6.3V shared rail:

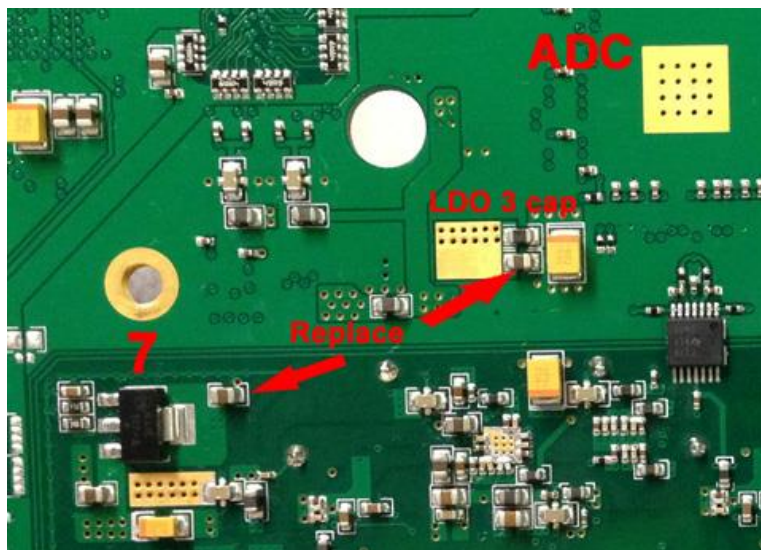
Sadly, there was no capacitor seen at LDO #3 output on the top side of the PCB. Was it on the bottom side? There was no choice left so I had to take the front panel off and sure enough there it was. And to my enjoyment there was another regulator (LDO #7) on the bottom:

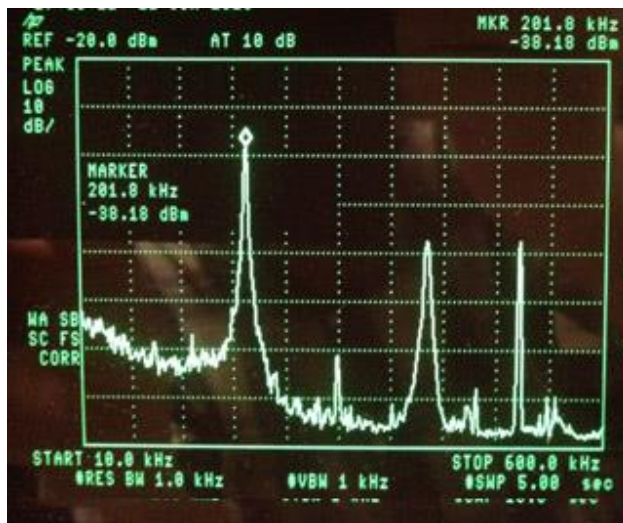
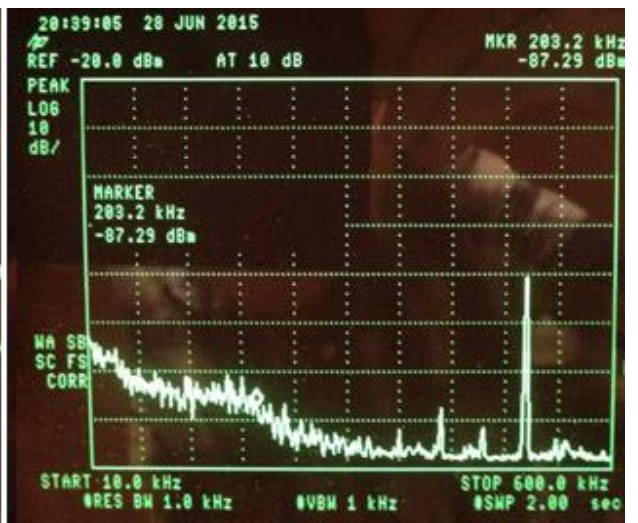
Shared +6.3V rail

Here is screenshots of the 6.3V shared power rail before and after the fix. To remind you again, all regulators for the analog front-end were sitting on that rail. The two leftmost peaks in the left picture is the oscillation cause by the LDO #3 and #7 output caps. I observed that the two peaks were moving back and forth as the oscilloscope started up, performed startup check and went to acquisition state. Evidently, frequency of oscillation depended on the load on the rail. And this can happen because variations in consumed power cause variation in the load impedance and that affects the regulator's feedback loop. The rightmost third peak was not caused by LDO oscillation; it was a leftover from the upstream switching power regulator working at 500kHz switching frequency. It was not affected by the caps swap and remained on the rail after the change as can be seem in the right picture.

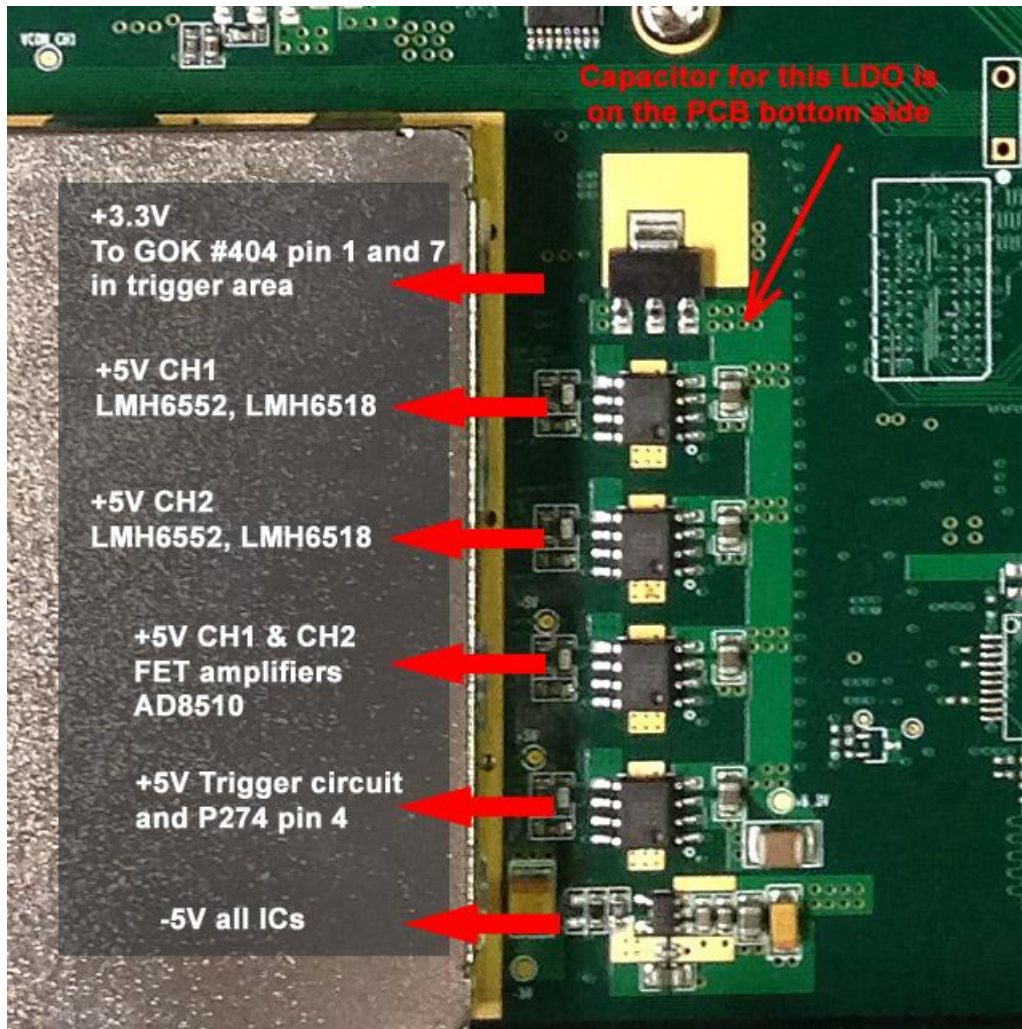
The following photo shows the power regulators for the analog input stage. Beside the top 1117 LDO, they are specified to work with ceramic capacitors and did not oscillate themselves, however before the fix they all had attenuated oscillation passing through them from their input 6.3V rail.
